A Comparative Study of Inspection Techniques for Array Packages

Jelila Mohammed
Christopher Green
NASA Electronic Parts and Packaging (NEPP)

April 28, 2008

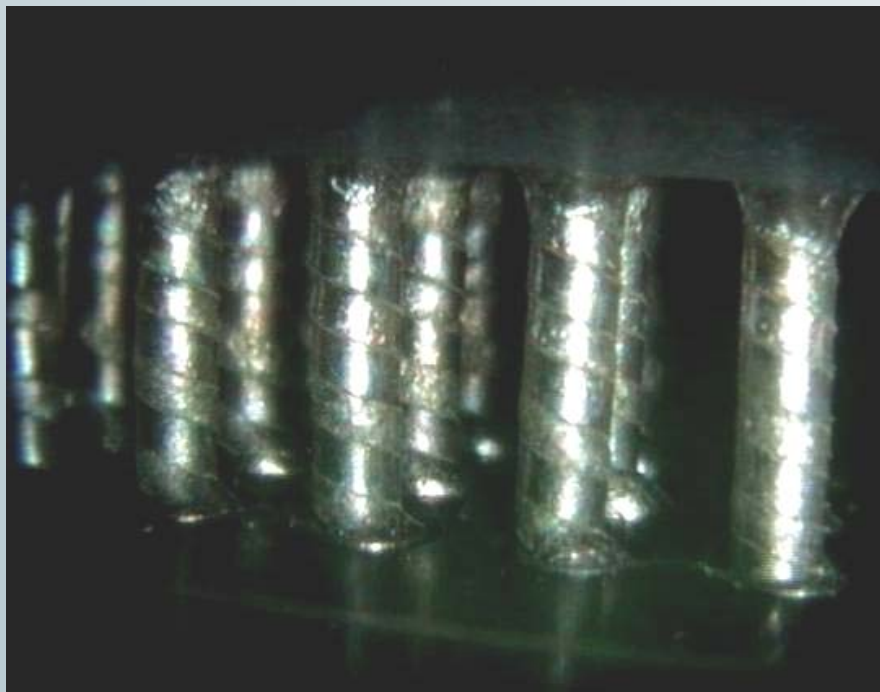
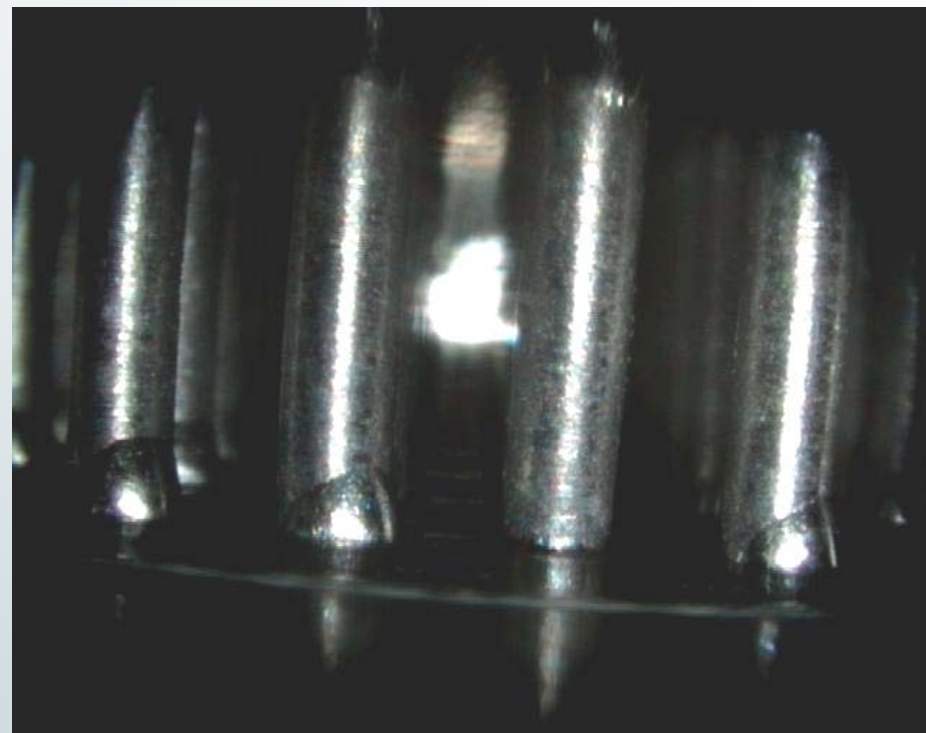
Aids in inspection of
column alignment

True color imaging of columns
and solder joints indicates good
solder quality

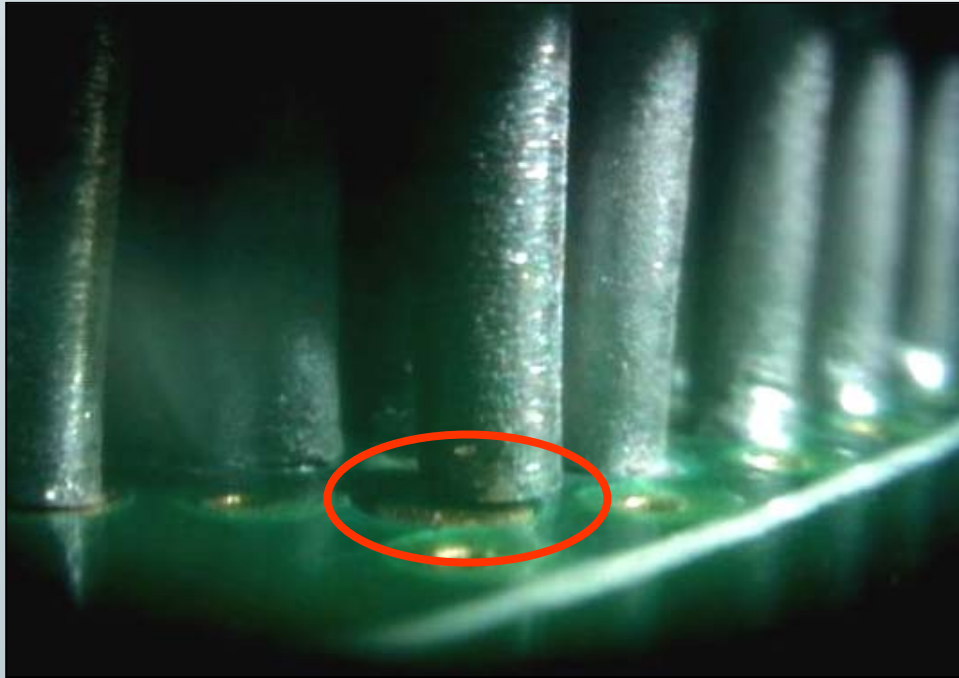
Defect - Solder Wetting

Optical inspection shows column is lifted off pad and has no solder attach at all.

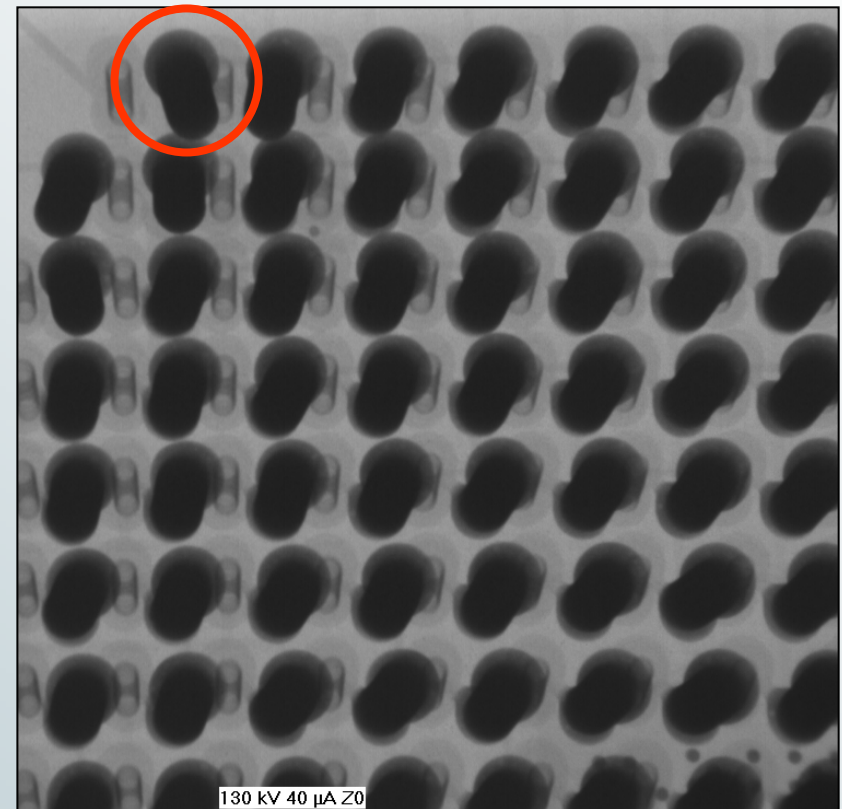
X-Ray inspection does not indicate the column is abnormal.

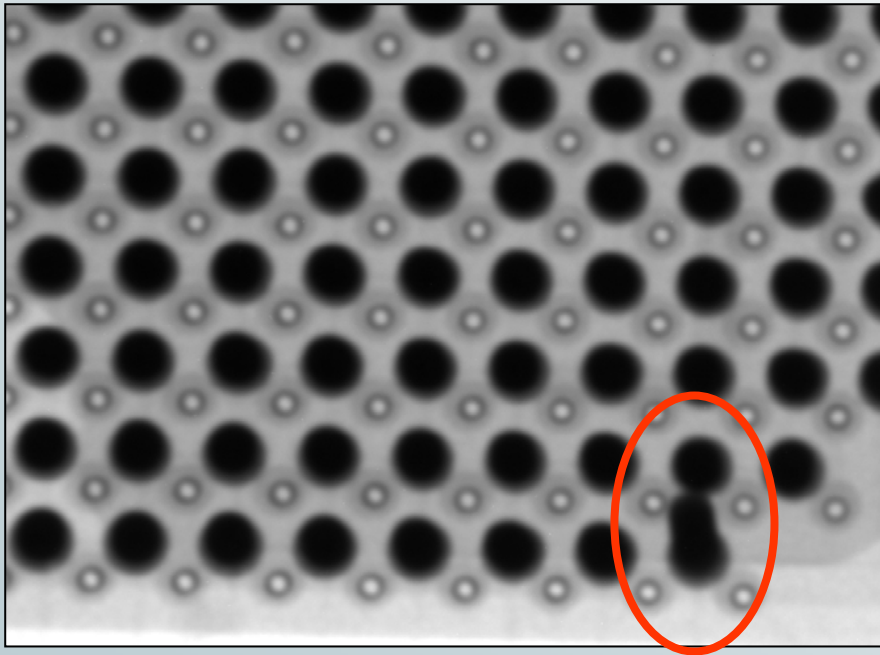
Defect - Bent/Shorted Columns

X-ray inspection shows the bent pin, but the short cannot be confirmed

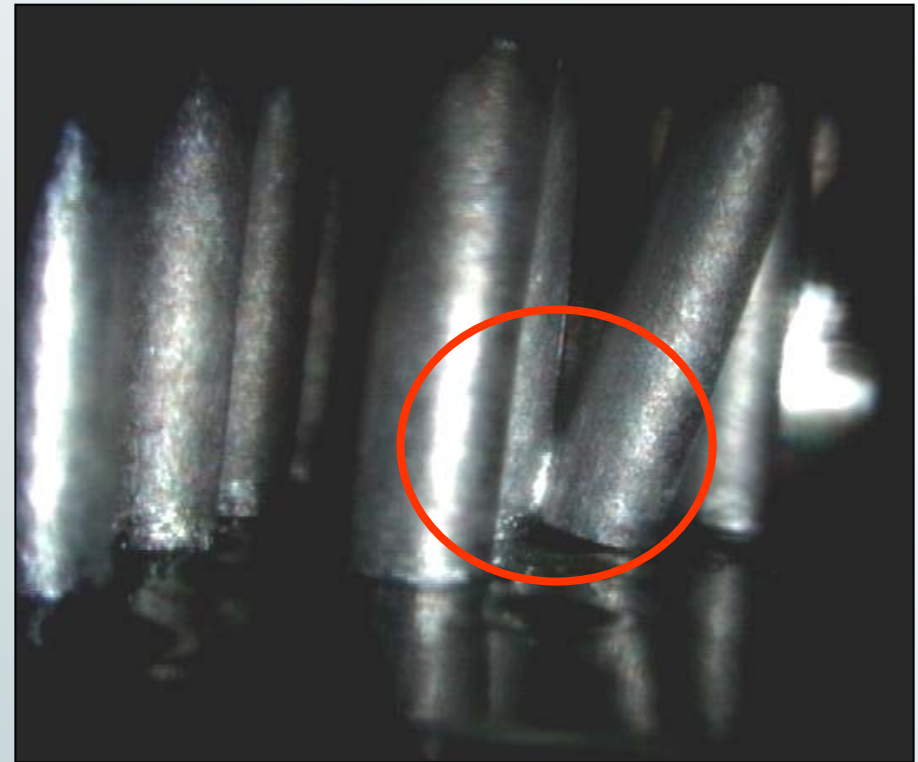
Optical inspection indicates that one pin is shorted to another

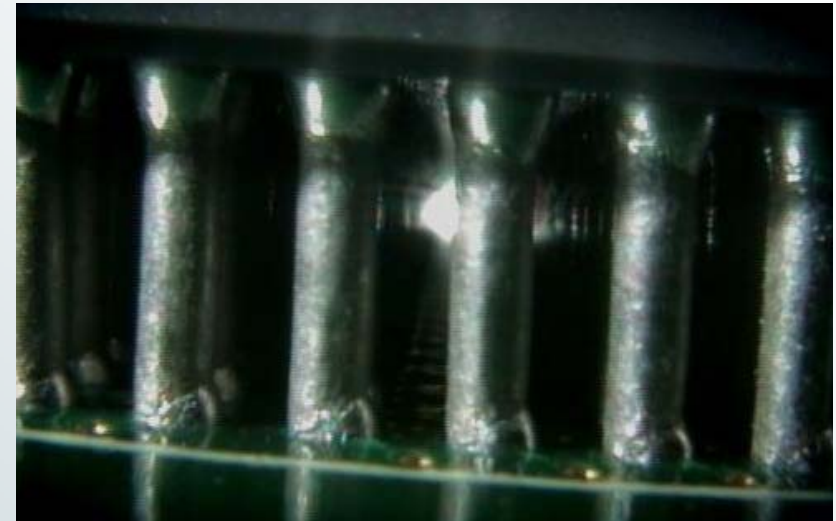
Defect - Bent Column

X-ray shows bent column in center of array, but inspection with the optical scope cannot clearly show center part of array.
